# QUAIL RUN AND LIBERTY GLASS DRAINAGE SYSTEM

## SAPULPA CITYWIDE MASTER DRAINAGE PLAN

JUNE 2010

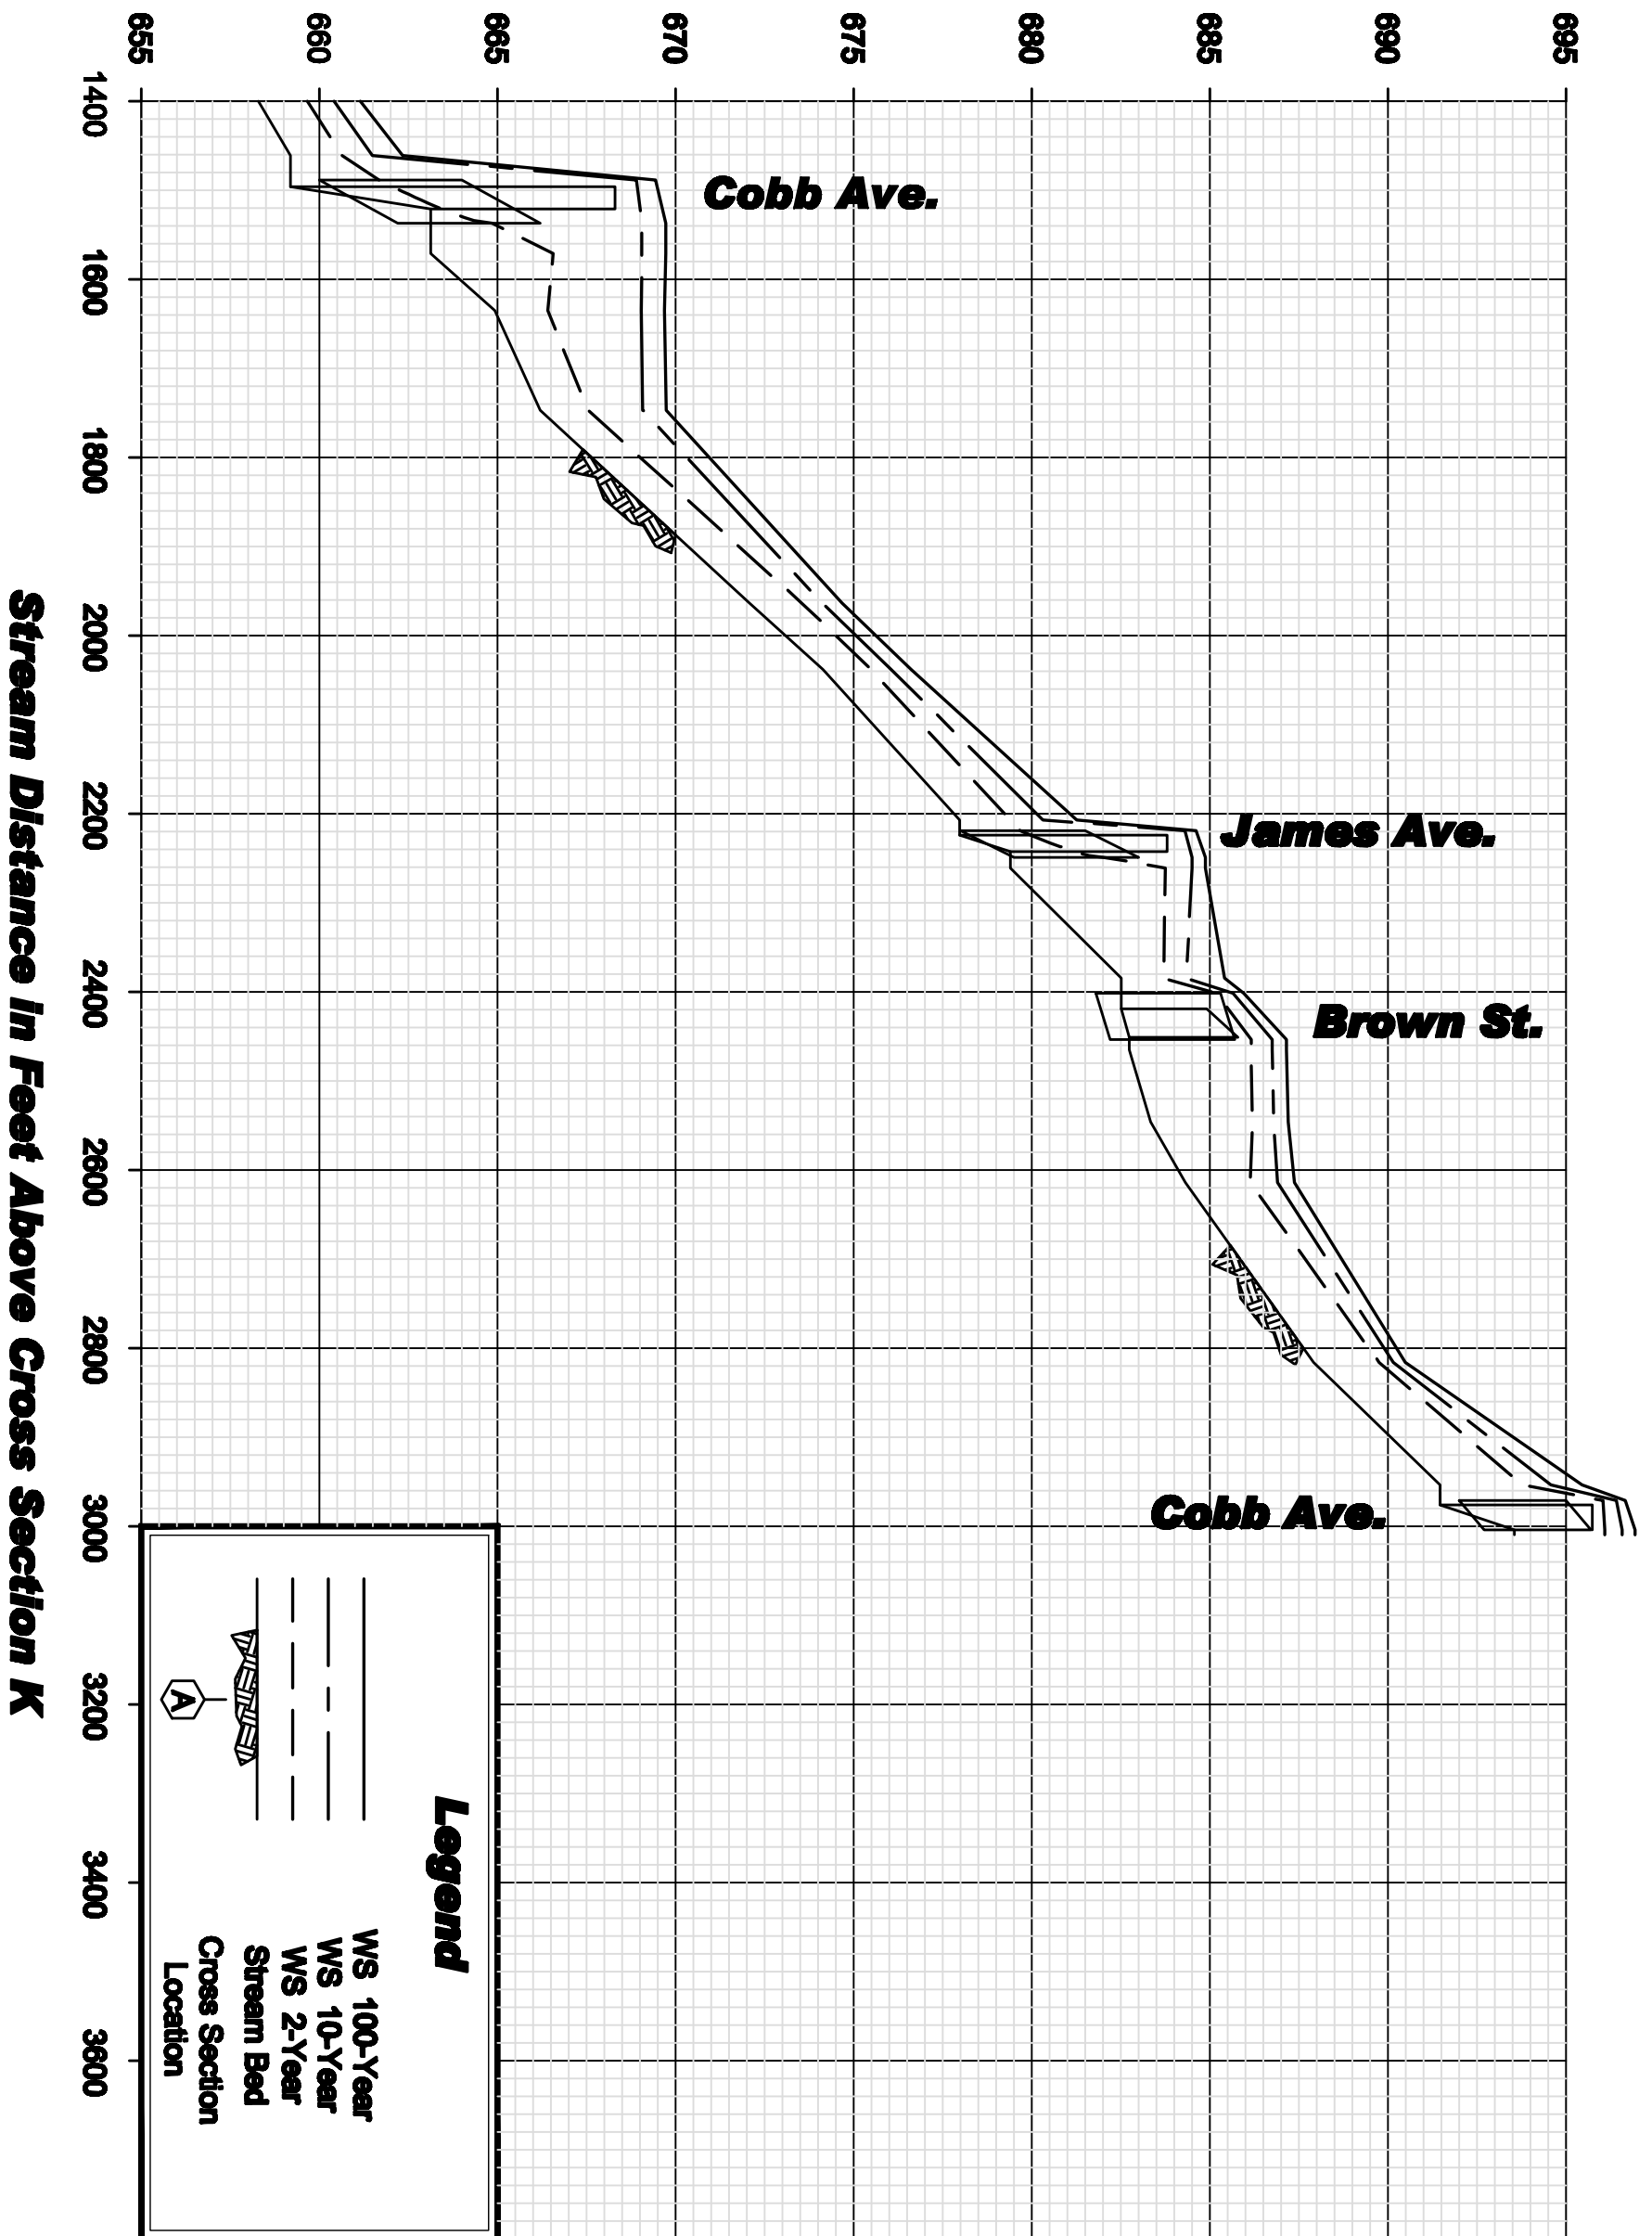
**Appendix 13-E-2  
 Existing Flood Profiles  
 North Polecat Creek  
 Liberty Glass Reach 1**

**Elevation  
(Feet NAVD '88)**

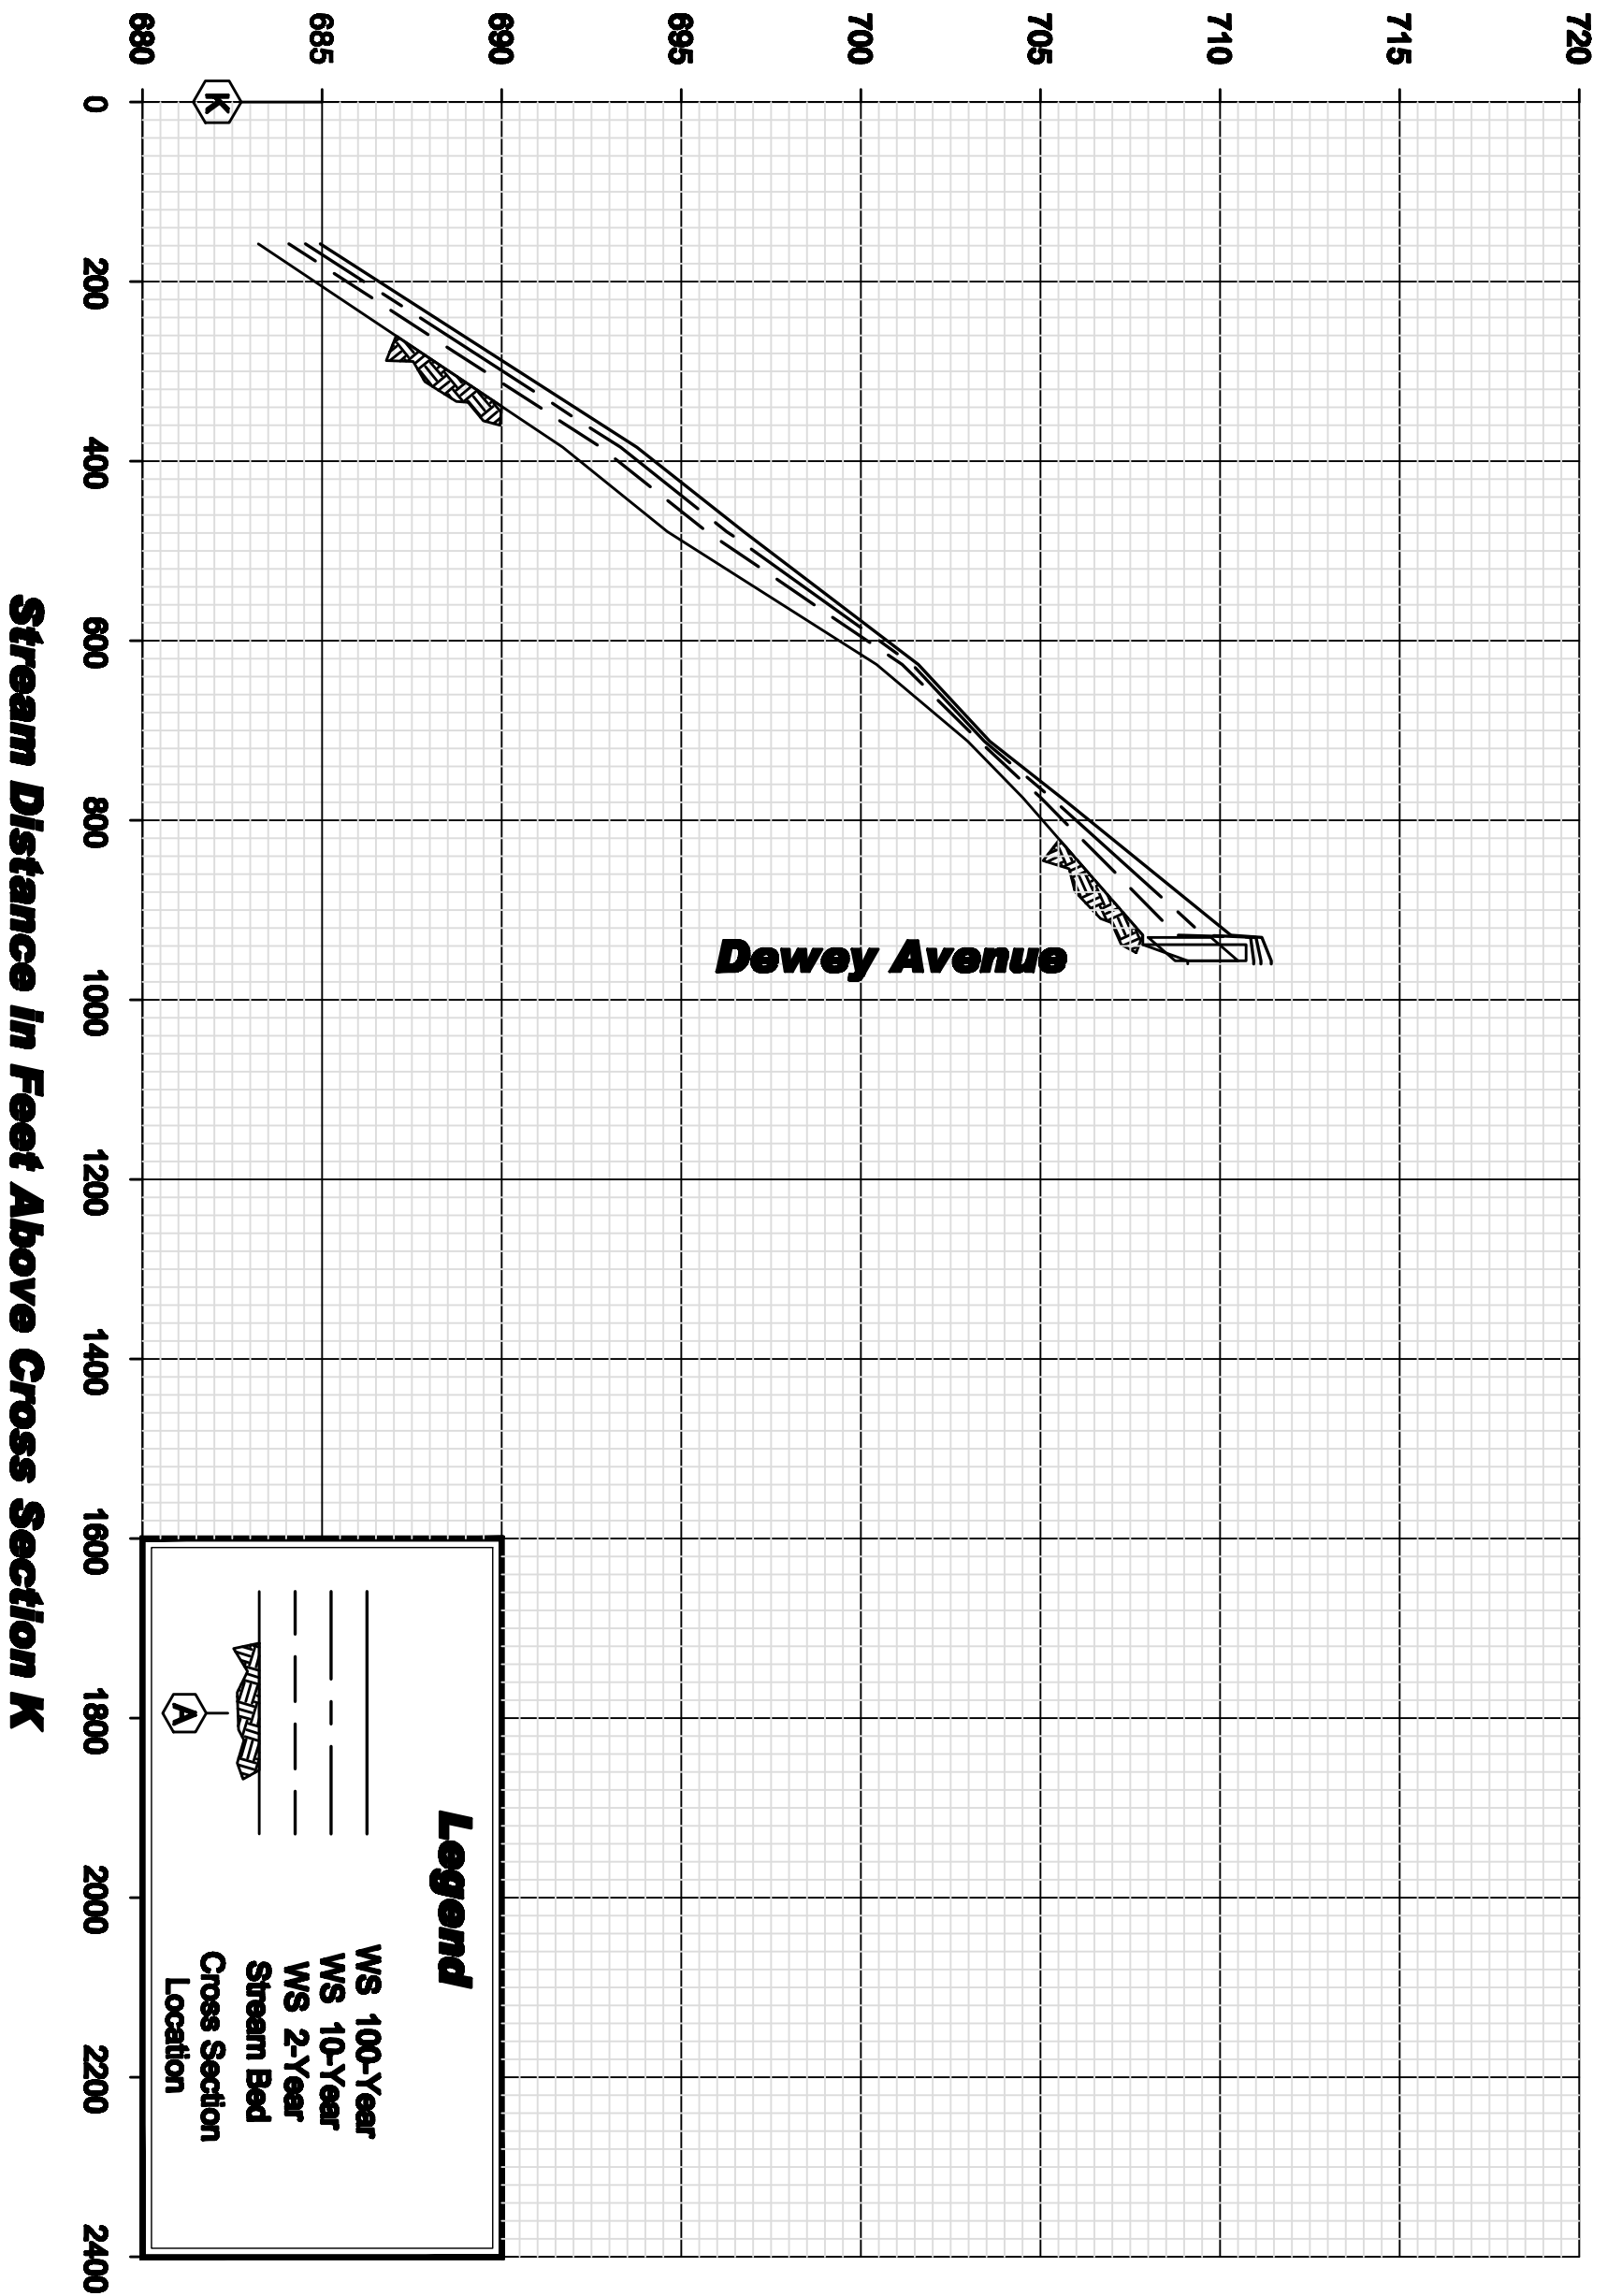
**Appendix 13-E-9  
 Existing Flood Profiles  
 North Polecat Creek  
 Qual Run Tributary A**

**Elevation  
(Feet NAVD '88)**

- WS 100-Year
- WS 10-Year
- WS 2-Year
- Stream Bed
- Cross Section Location
